Walk Around

TBF/TBM Avenger

Walk Around Number 25
squadron/signal publications

By Lou Drendel

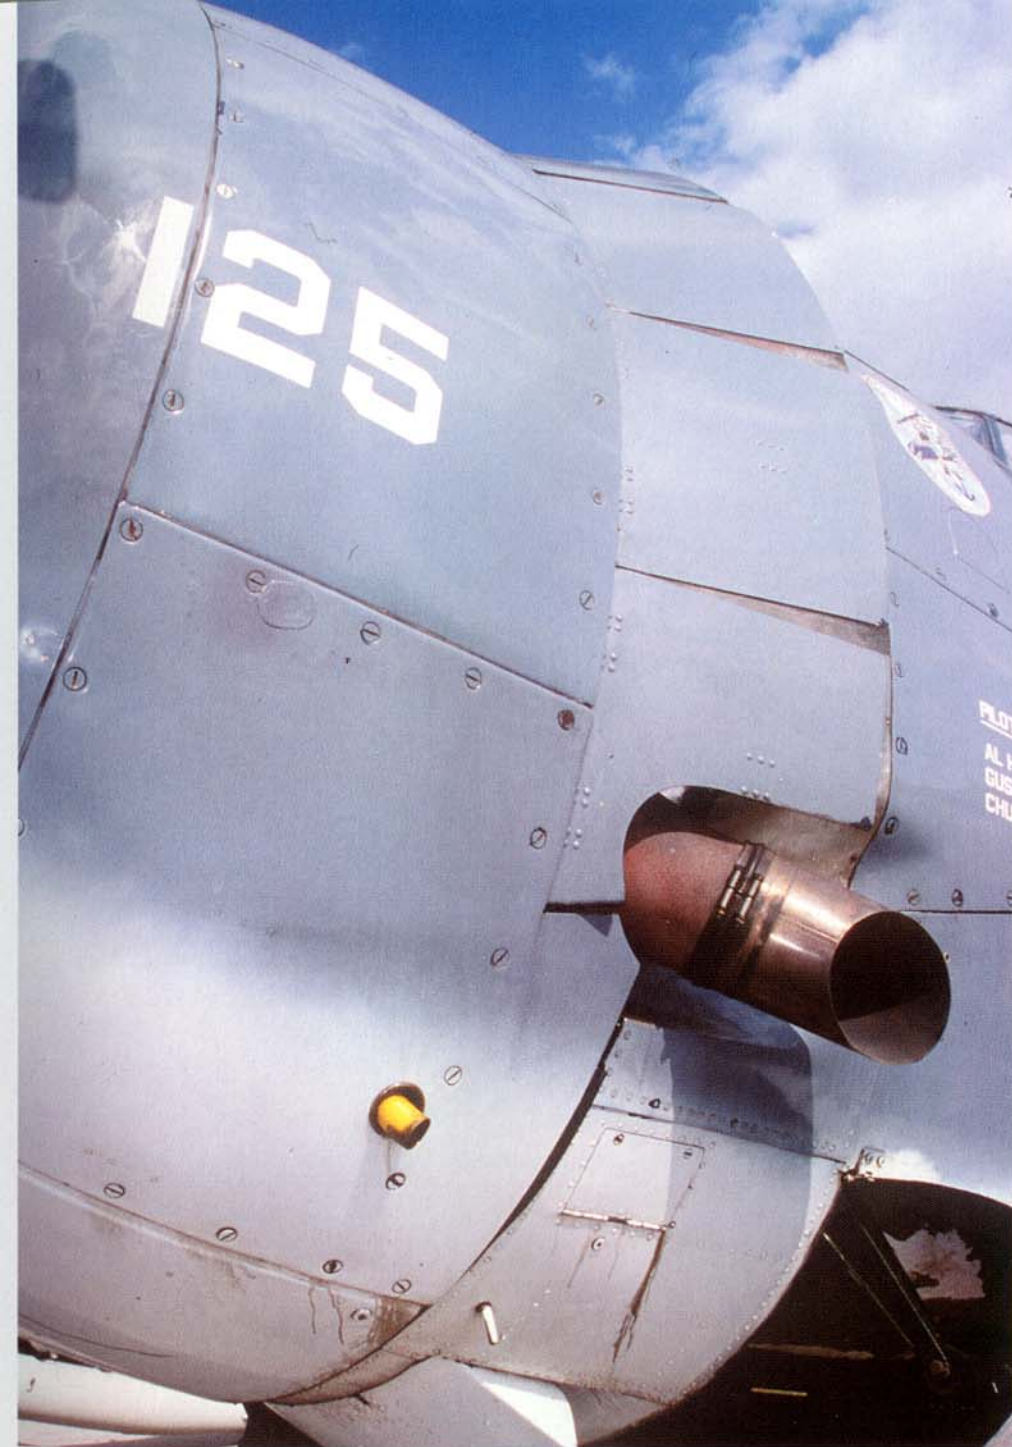
The cowl flaps were extended on this idle TBM-3's engine cowling. The cowl flaps were fully opened during engine warm up and ground operation and partially open for climbing to cruise altitude. These flaps were usually closed for level flight and cruising climbs under normal temperature conditions. The oil overflow pan drain was placed on the lower port cowling area. (Lou Drendel)

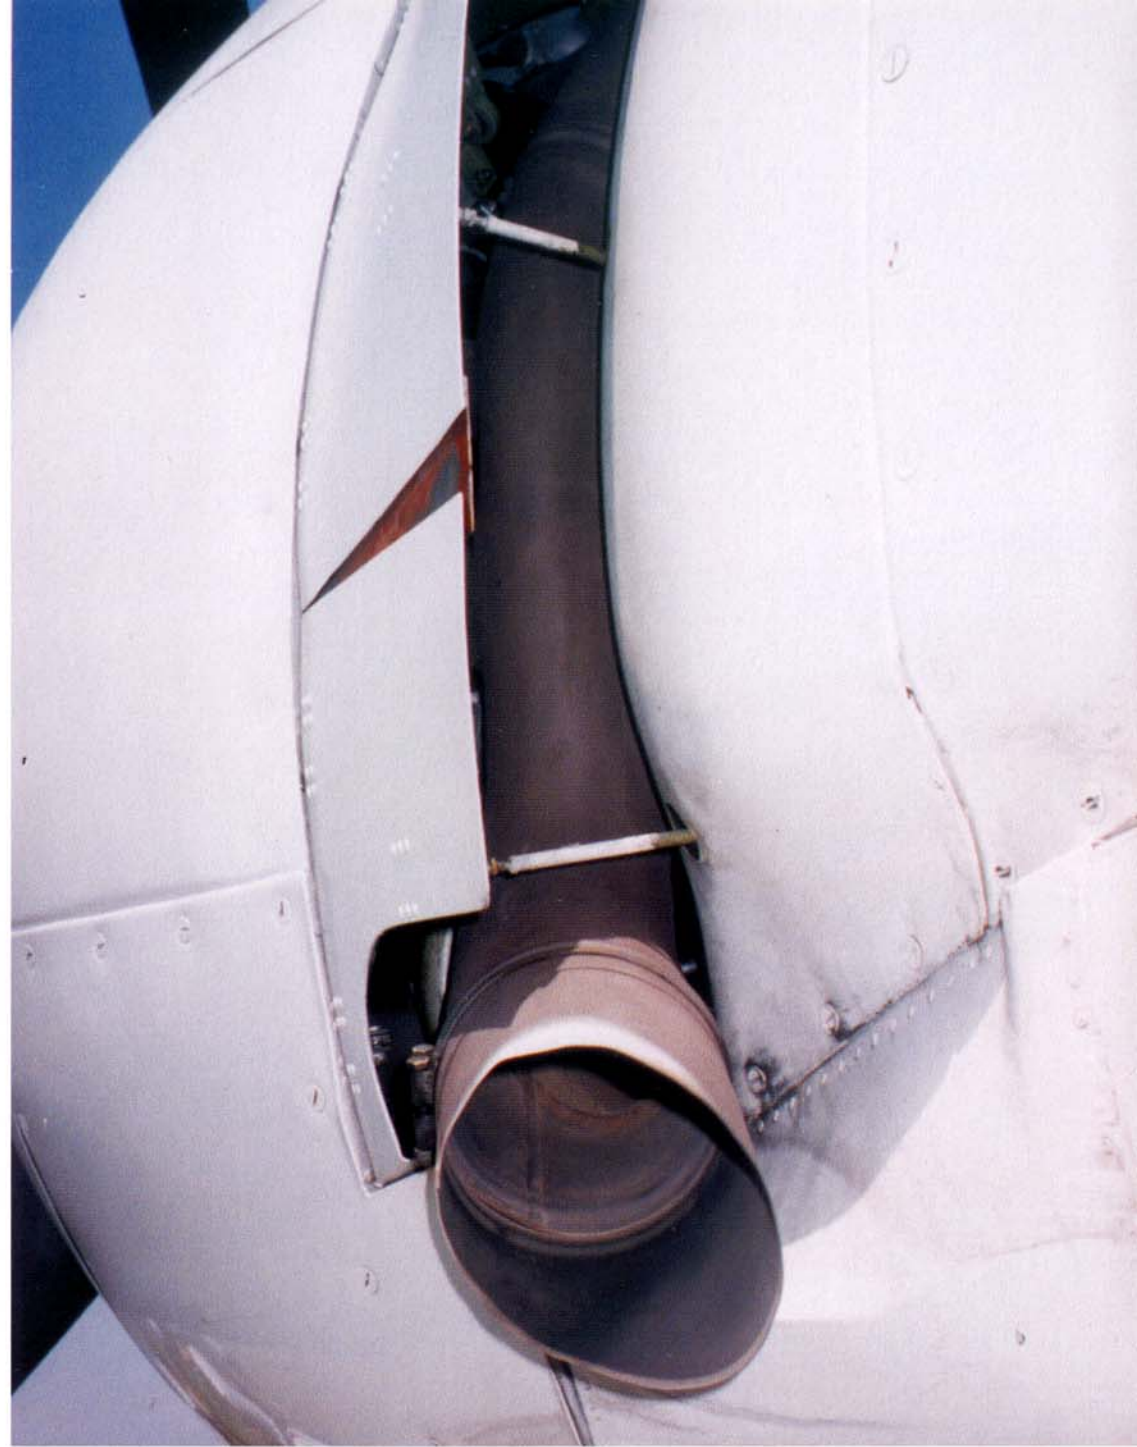
Cowl flap actuating rods adjusted the position of these flaps based on input from the cockpit. The pilot could set the cowl flaps in either the open, closed, or neutral (intermediate) positions. The earlier TBF/TBM-1 had only one cowl flap per cowling side, as opposed to the TBM-3's four flaps per side. The exhaust collector ring fed engine exhausts to the exhaust stack. (Lou Drendel)

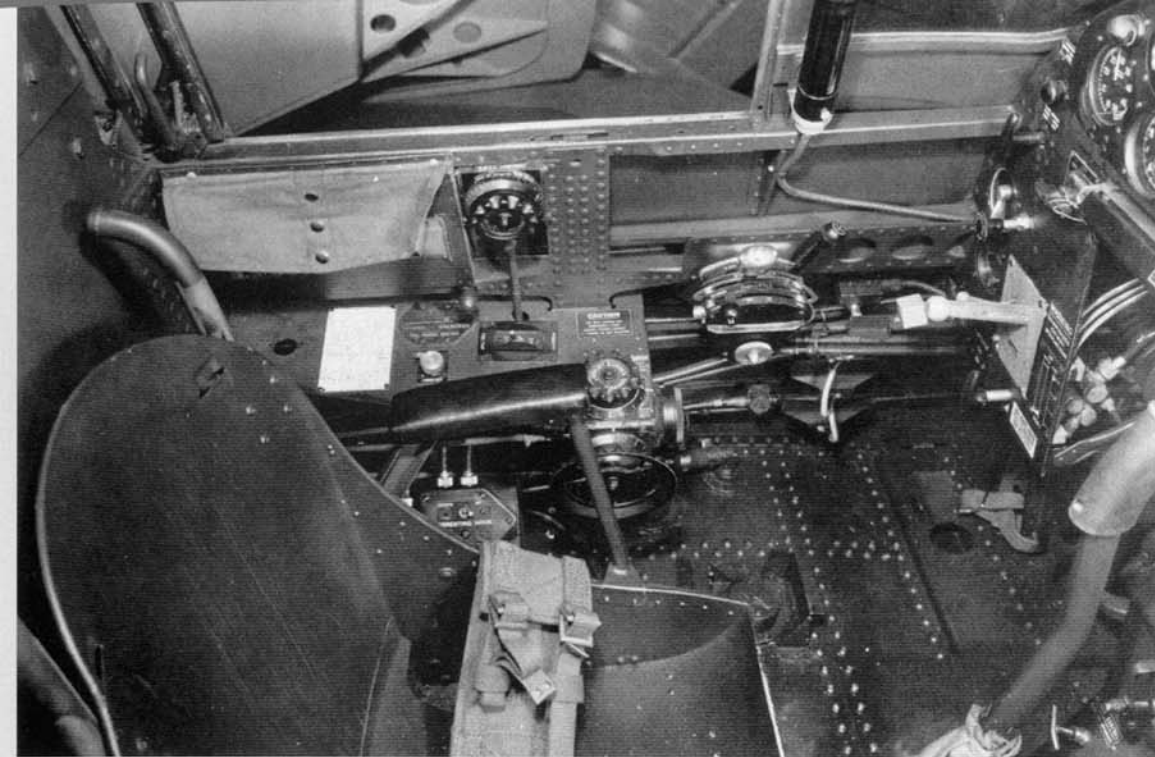
The flap and landing gear control levers were placed on the TBF-1's port instrument panel section. The throttle quadrant was placed aft of this panel under the canopy rail. The supercharger control was mounted outboard of the throttle. Rudder and elevator trim controls were behind the throttle quadrant, while the arresting gear (tail hook) control switch was located beside the pilot's seat edge. (Grumman)

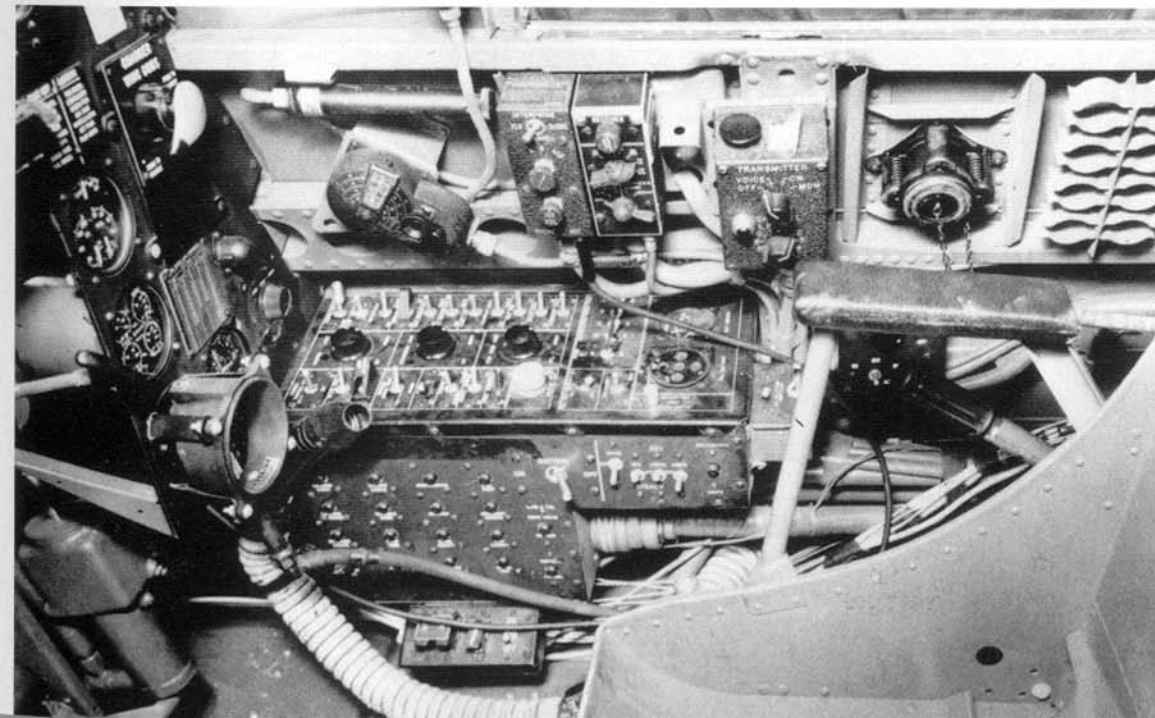
The electrical distribution panel was located immediately aft of the starboard instrument panel section. Radio controls were placed above and below the right side console. Above the seat armrest was the signal flare launcher, with racks for flares aft of this launcher. The pilot's seat had room to allow a parachute to be worn as a seat cushion. (Grumman)

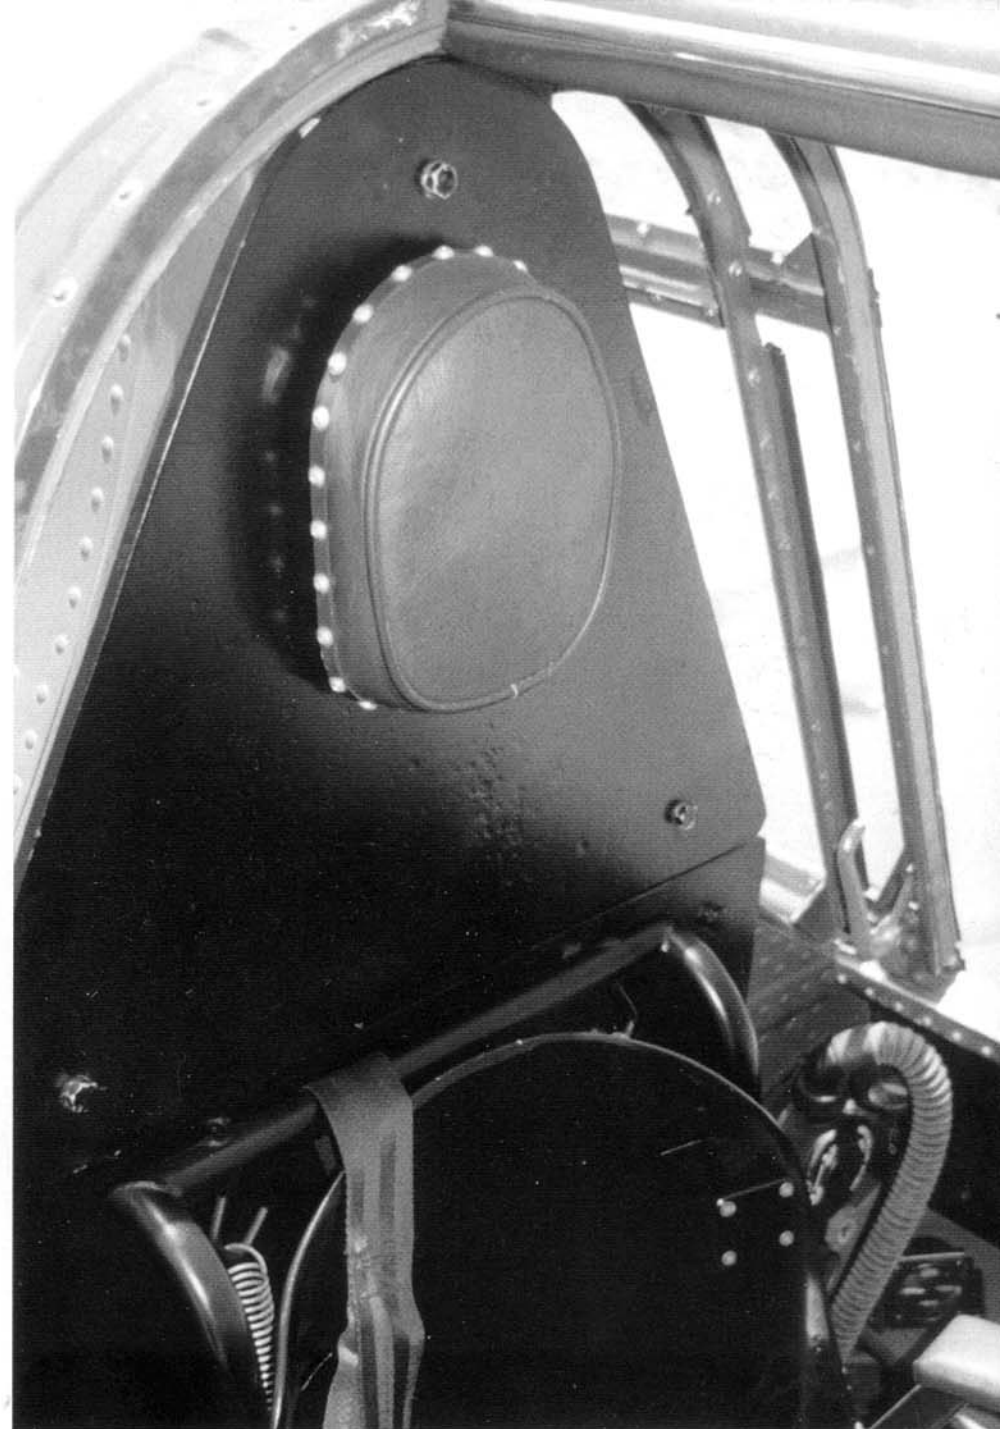
The TBM-3's seatback armor plate and padded headrest were the same in earlier Avenger models. The armor plate behind the pilot's seat was .375 inch (9.5mm) thick, while the armor supporting the headrest was .75 inch (19.1mm) thick. The TBM-3 pilot's seat height was adjusted using steel springs behind the seat, which replaced shock cords fitted to earlier Avenger models. (Lou Drendel)

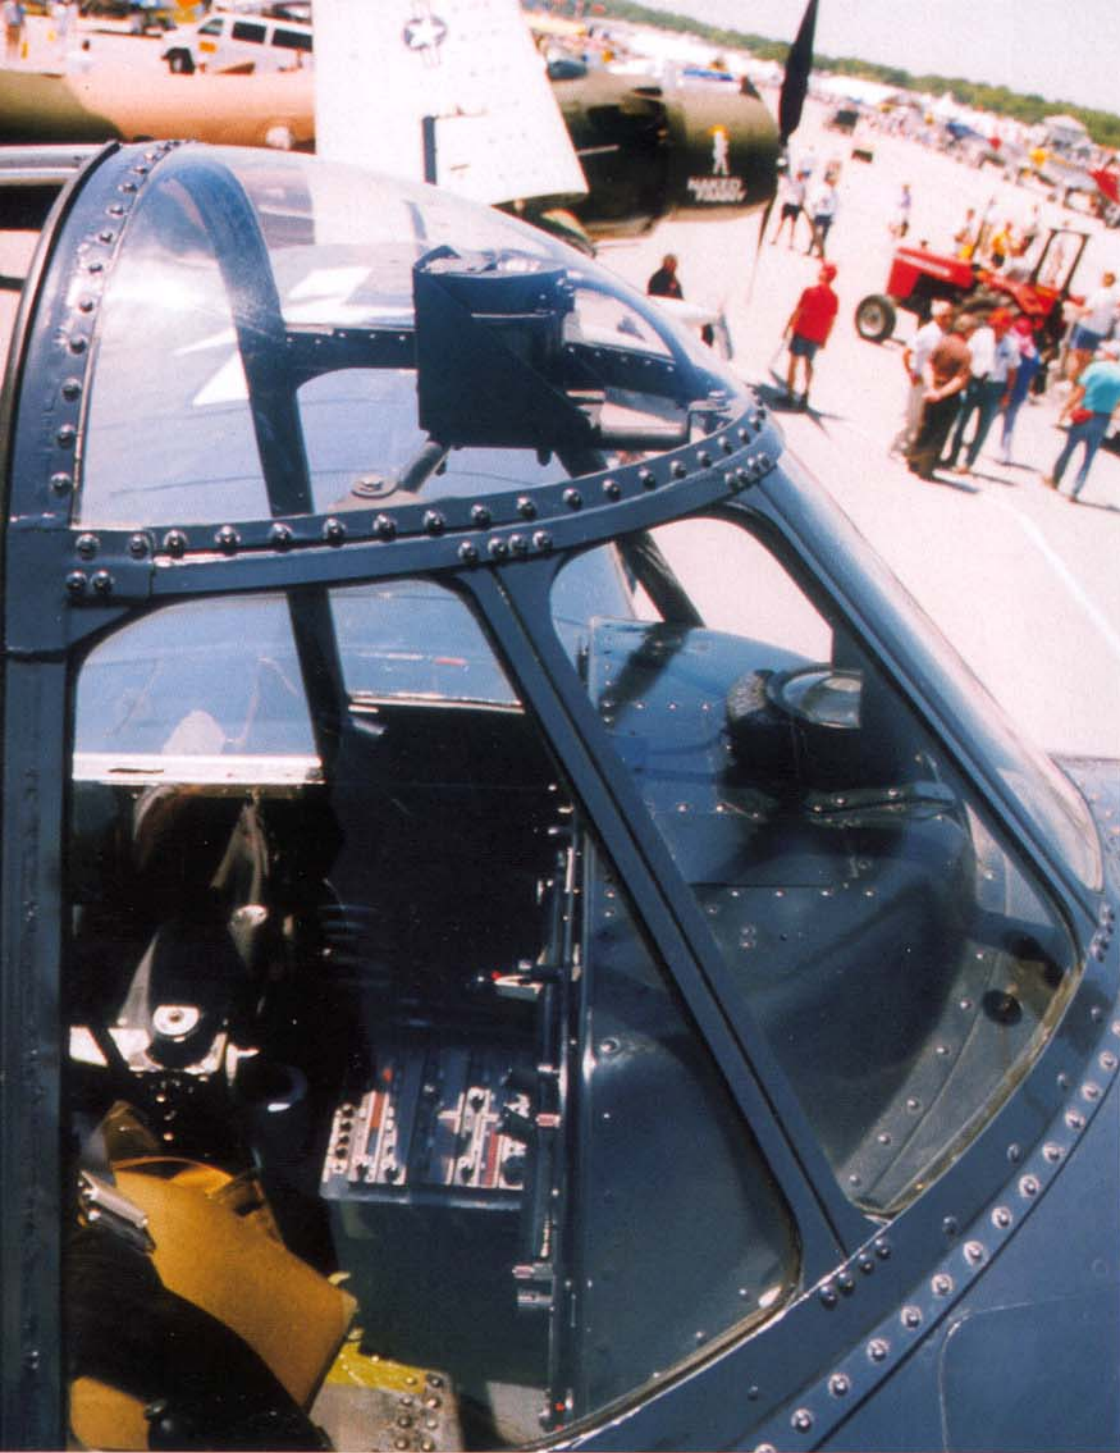
A Mark 8 reflector gunsight was mounted atop the instrument panel shroud under the TBM-3's windshield. This sight allowed pilots to line up aerial targets for the two wing-mounted .50 caliber (12.7mm) machine guns and for torpedo attacks. A magnetic compass was placed under the windshield's uppermost panel to allow accurate readings without undue interference by the aircraft's metal structure. (Lou Drendel)

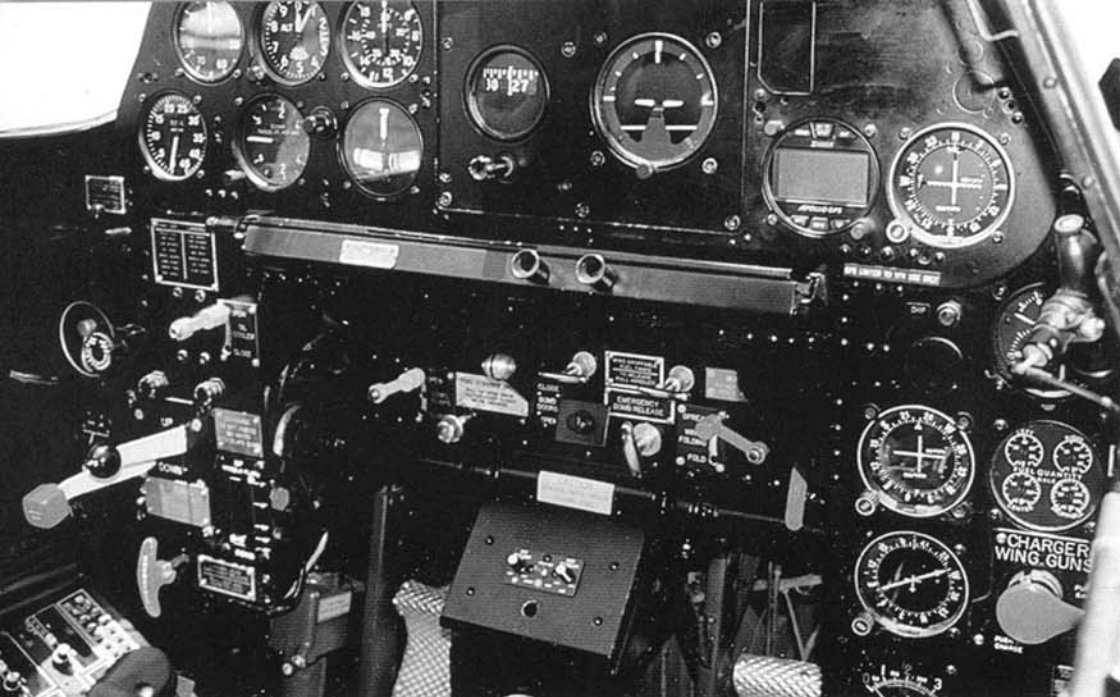
Several modern instruments were installed in the upper right instrument panel of the Cavanaugh Flight Museum's Avenger. Controls under the plotting board included the yellow cowl flap crank (port) and the red wing fold crank (starboard). The bomb bay door control was placed in the lower panel's center. (Lou Drendel)

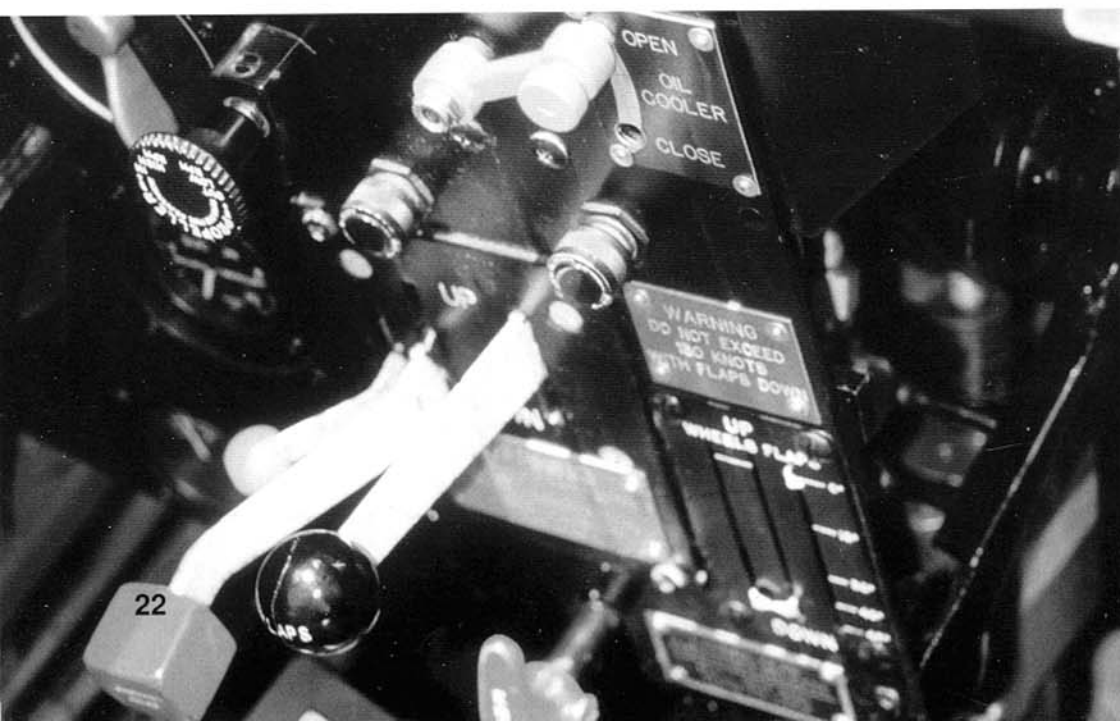
The flap and landing gear handles were placed on the TBM instrument panel's port side. The flap lever had a red square handle, while the landing gear lever used a black round handle. The size and shape of these handles allowed for easy recognition by the pilot in all lighting conditions. Mechanical position indicators for both levers were placed to starboard of these handles. (Lou Drendel)

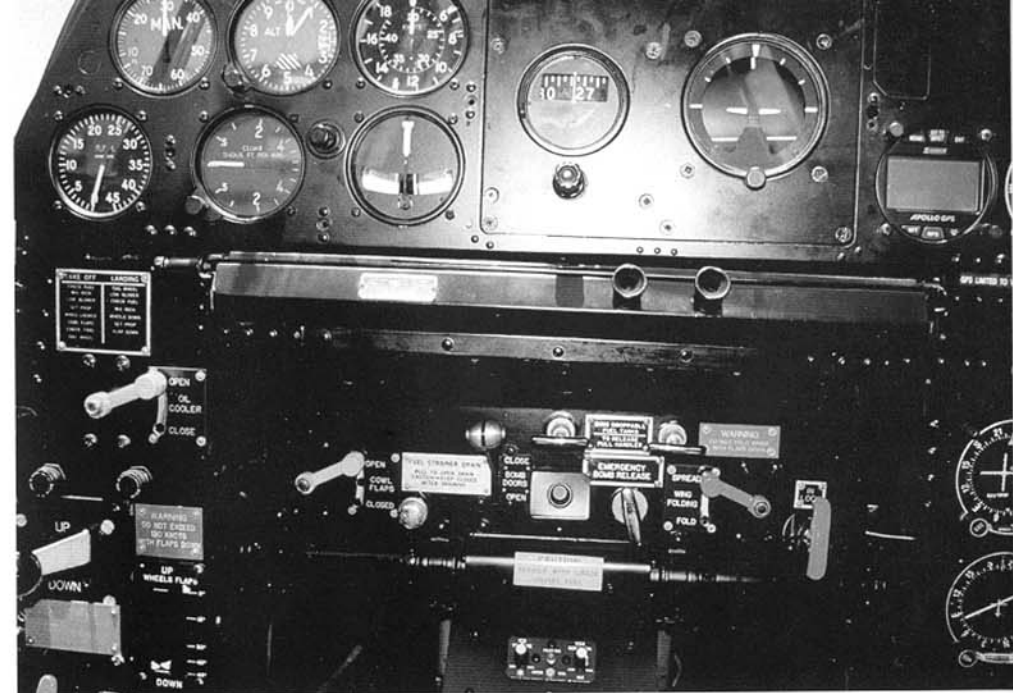
The Cavanaugh Avenger's panel contains many original instruments, with modern avionics displays confined to the starboard side of the panel. These included a GPS (Global Positioning System) receiver just above the right edge of the retracted plotting board. The Instrument Black (FS27038) panel color was authentic for US World War II-era military aircraft. (Lou Drendel)

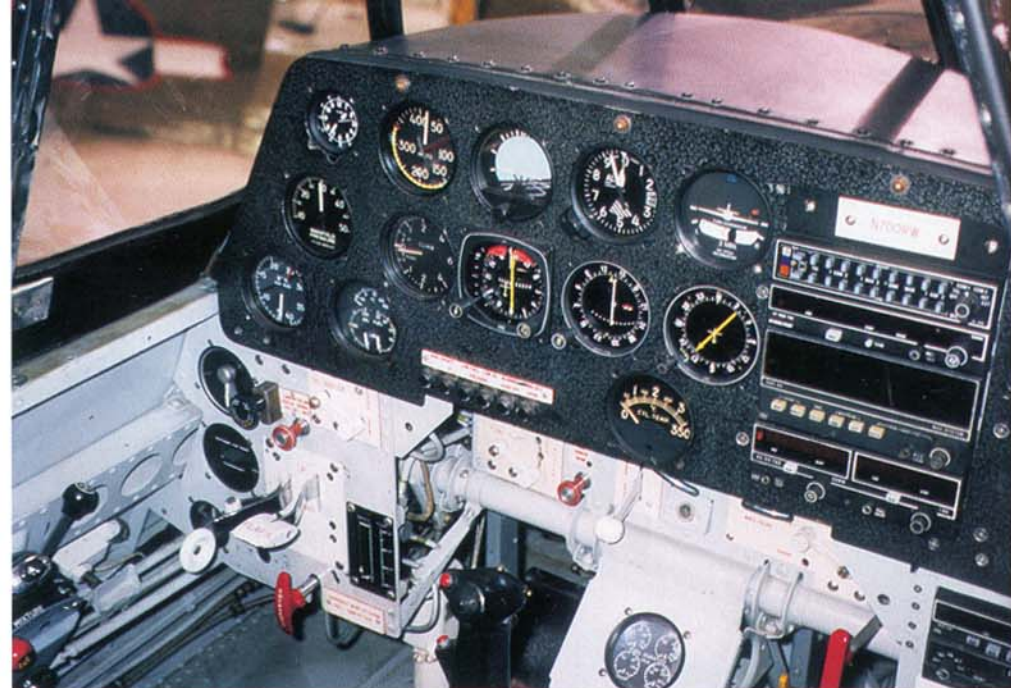
The TBM (N700RW) owned by the Lone Star Flight Museum in Galveston, Texas was fitted with modern avionics and instruments. This arrangement does not resemble the original aircraft's instrument panel in any way. The control stick grip is a modern type with multiple task buttons, not the relatively simple grip used on wartime Avengers. The upper portion of the instrument panel is Flat Black, while the rest of the cockpit interior is a light blue-gray (approximately FS35526). (Lou Drendel)

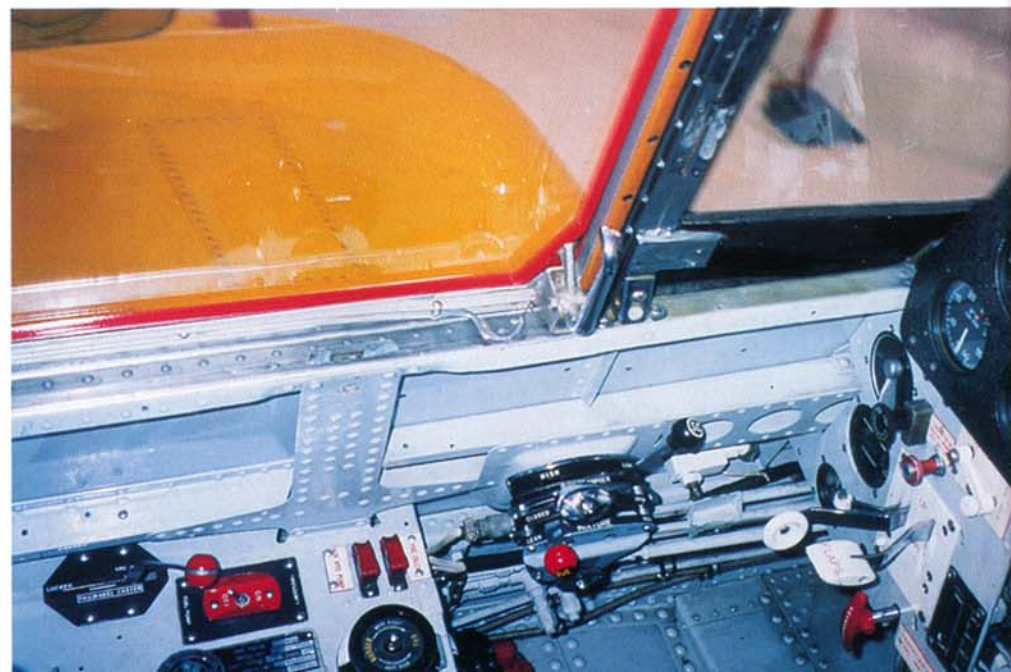
The port cockpit controls on the Lone Star Flight Museum's Avenger are in their original positions; however, the light blue-gray finish applied to this aircraft is incorrect. The round black knob on the fore end of the console was the rudder trim tab control. Below and slightly ahead of this knob – along the front of the console – was the aileron trim tab control wheel, which adjusted the TBM's aileron trim tabs as required under various flight conditions. (Lou Drendel)

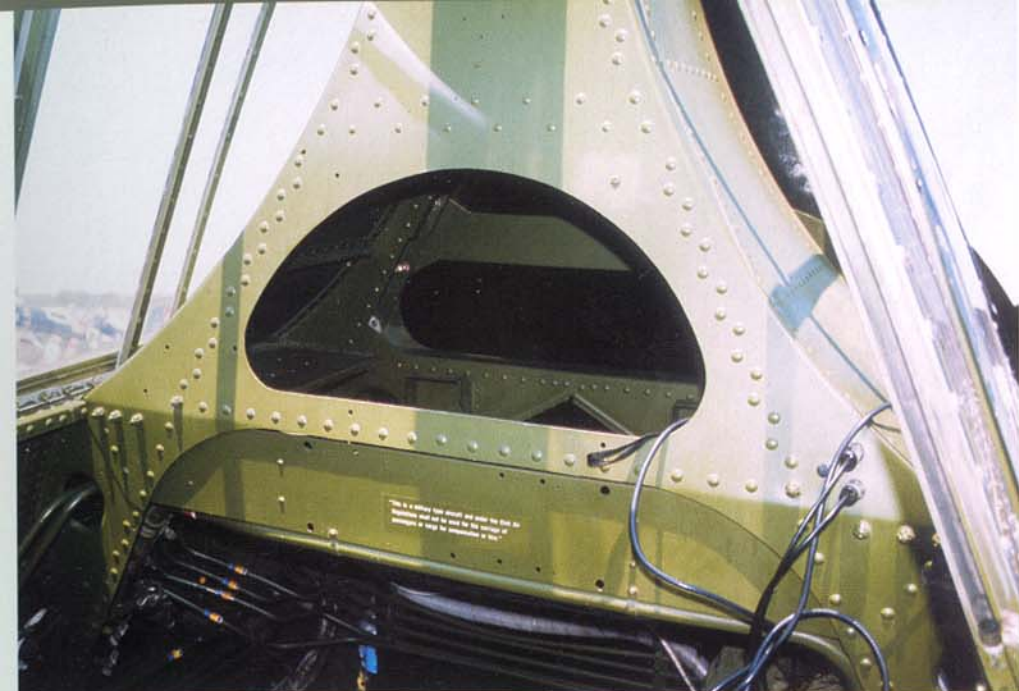
A roll-over crash pylon was mounted immediately aft of the pilot's seat to absorb any likely loads in the event the Avenger overturned on the ground. Early TBF-1s had basic flight instruments mounted within the semi-circular opening in the crash pylon. These instruments were deleted from the TBF-1C and later models, with provision made for placing radio equipment in this area. (Lou Drendel)

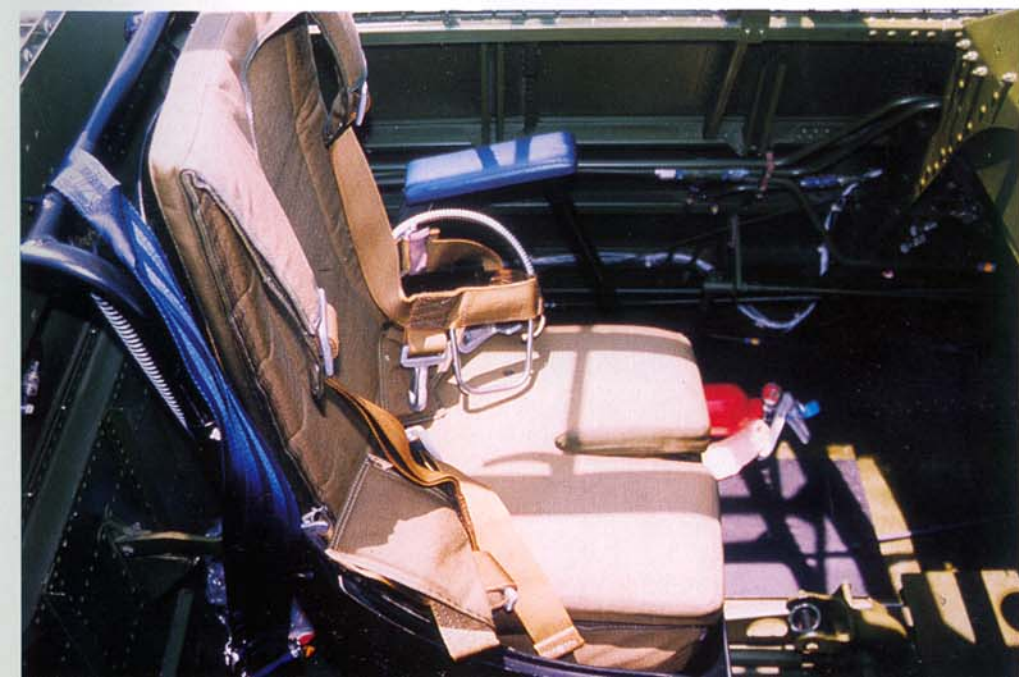
The radio operator's chair – not standard on Avengers after the TBF-1 – was fitted to the Cavanaugh Flight Museum's TBM-3. This center cockpit restoration is close to the original, the only exception being the red modern fire extinguisher fitted along the port cockpit wall just ahead of the pilot's seat. Most Avengers from the TBF-1C replaced the chair with radio equipment; however, the British used this seat on their Tarpon (later Avenger) Mk IIs (TBF-1Cs). (Lou Drendel)

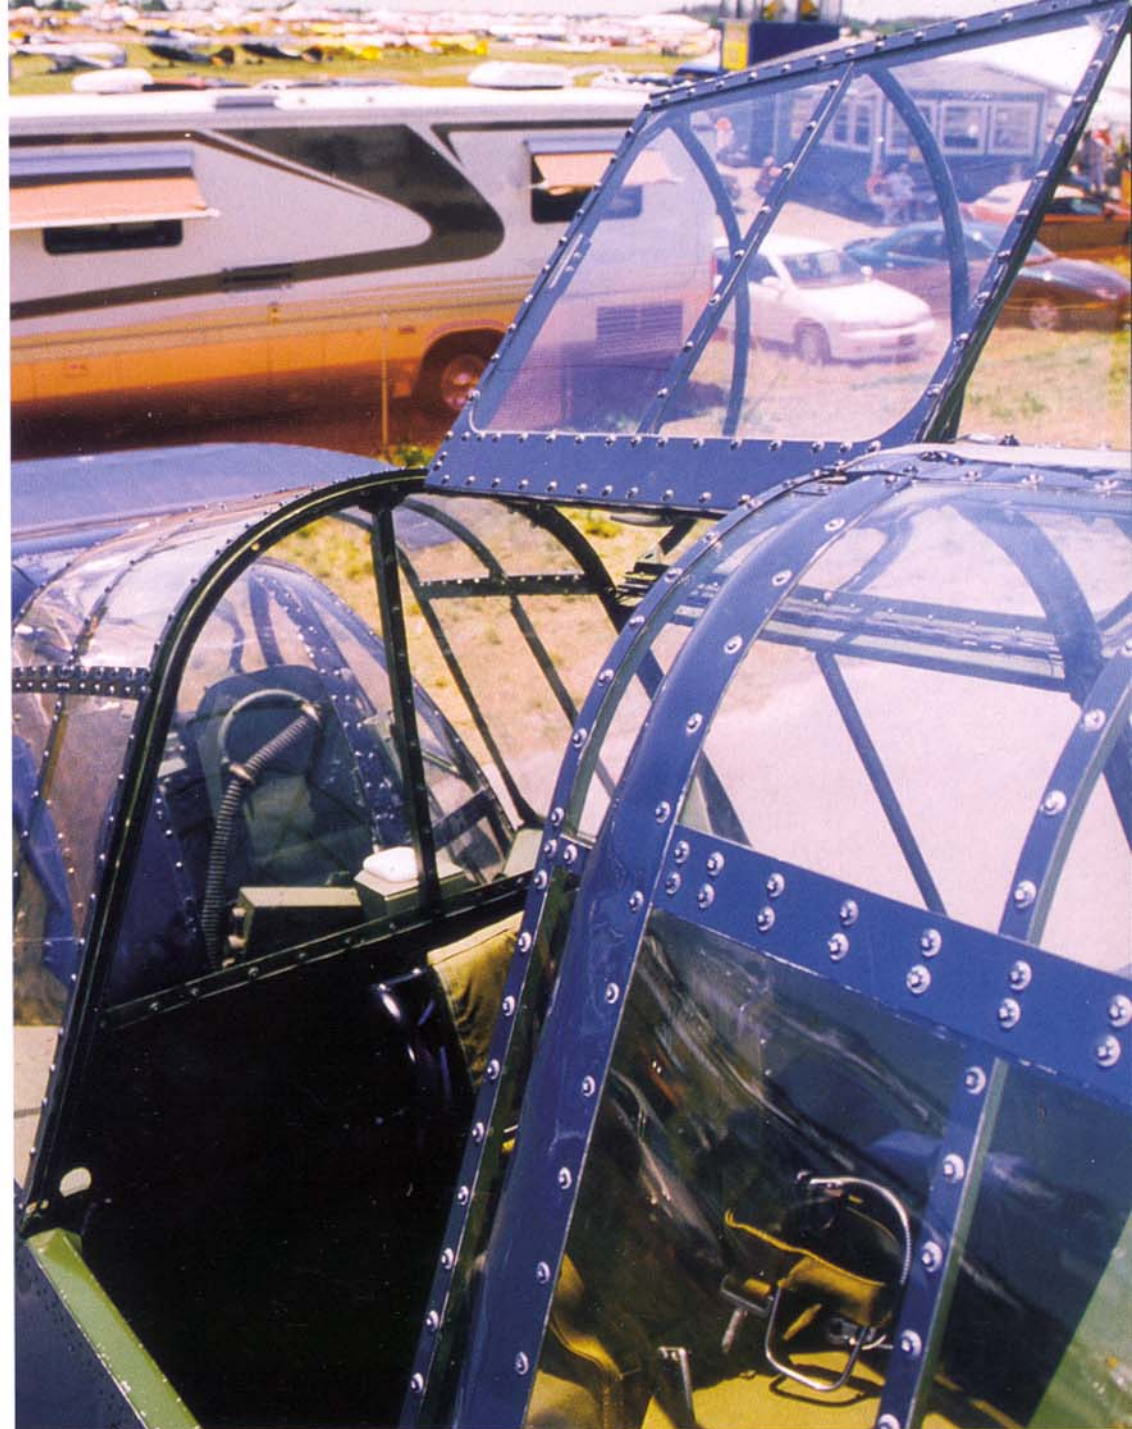
The radio operators canopy was located just forward of the Avenger's turret. The starboard and center sections hinged to port, while the left panel remained fixed in position. There were no clear panels separating the radio operator's cockpit from the aft canopy and rear turret. The canopy inner surfaces were painted Interior Green (FS34151), while the exterior surfaces were finished Glossy Sea Blue (FS15042) to match the fuselage exterior. (Lou Drendel)

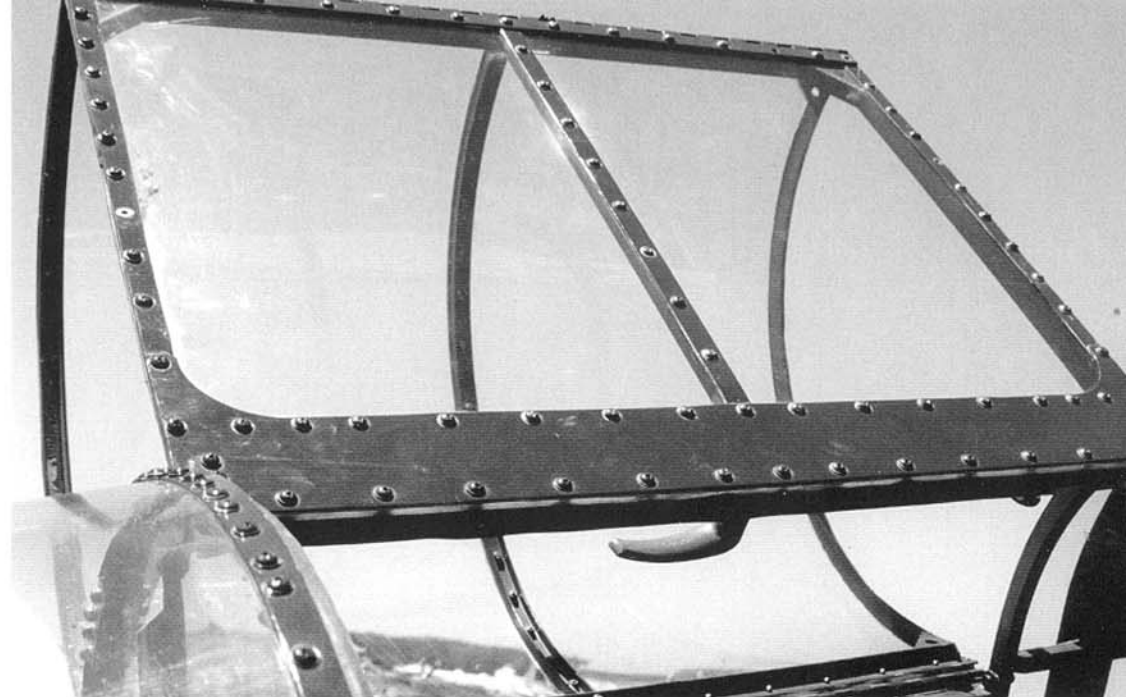
A folding door handle was mounted inside the lower starboard radio operator's canopy. The crewman turned this handle upon closing the canopy to lock this into position. Each of the individual Plexiglas canopy sections was removable for replacement if damaged. Rubber seals along the inner canopy surfaces kept water out of the cockpit. (Lou Drendel)

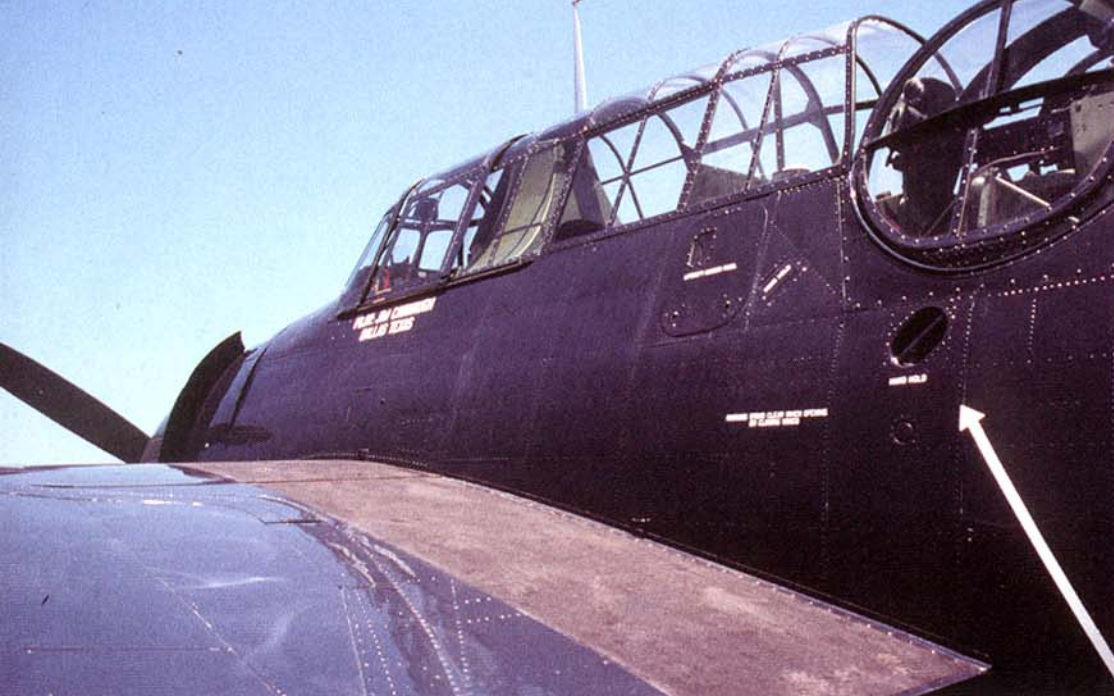
The TBF/TBM's gun turret protected the aft and side uppersurface of the aircraft from enemy fighters. A flush-mounted handhold under the turret assisted crewmen in climbing aboard the port side of the Avenger. The wingwalk areas were covered with a non-skid surface to ease the footpath for flight and maintenance personnel. (Lou Drendel)

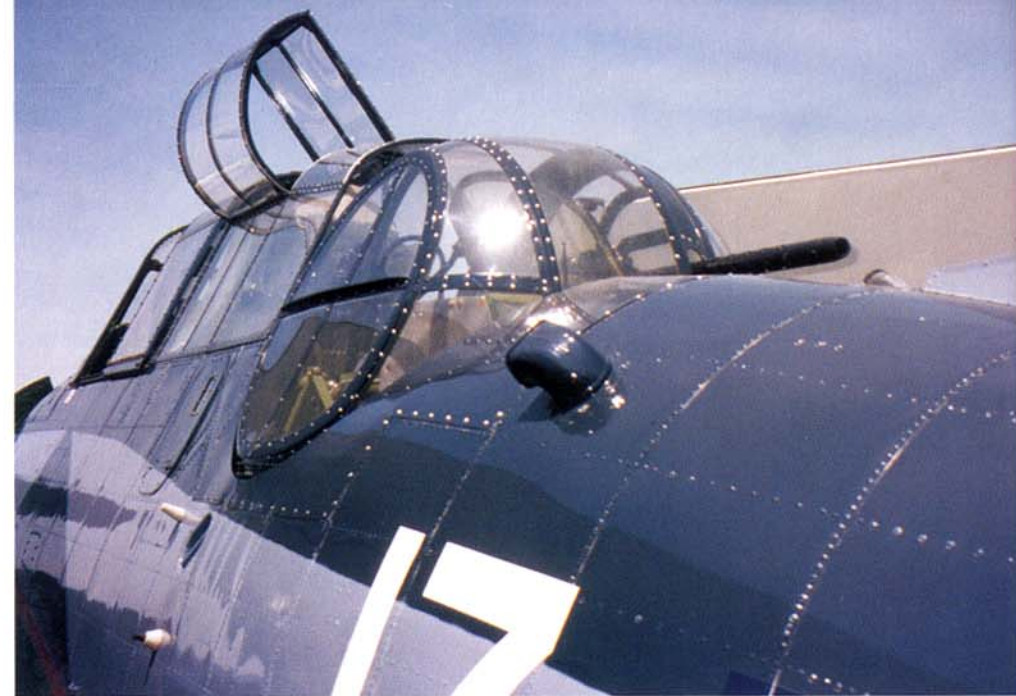
The .50 caliber Browning M2 machine gun was offset to the gunner's left to allow space for the gunner and his sighting equipment. The gunner used a ring and post gunsight – mounted behind 1.5 inch (38.1mm) thick bulletproof glass – to aim his weapon. The machine gun was trained and fired using a pistol-grip control device mounted under the gunsight. (Lou Drendel)

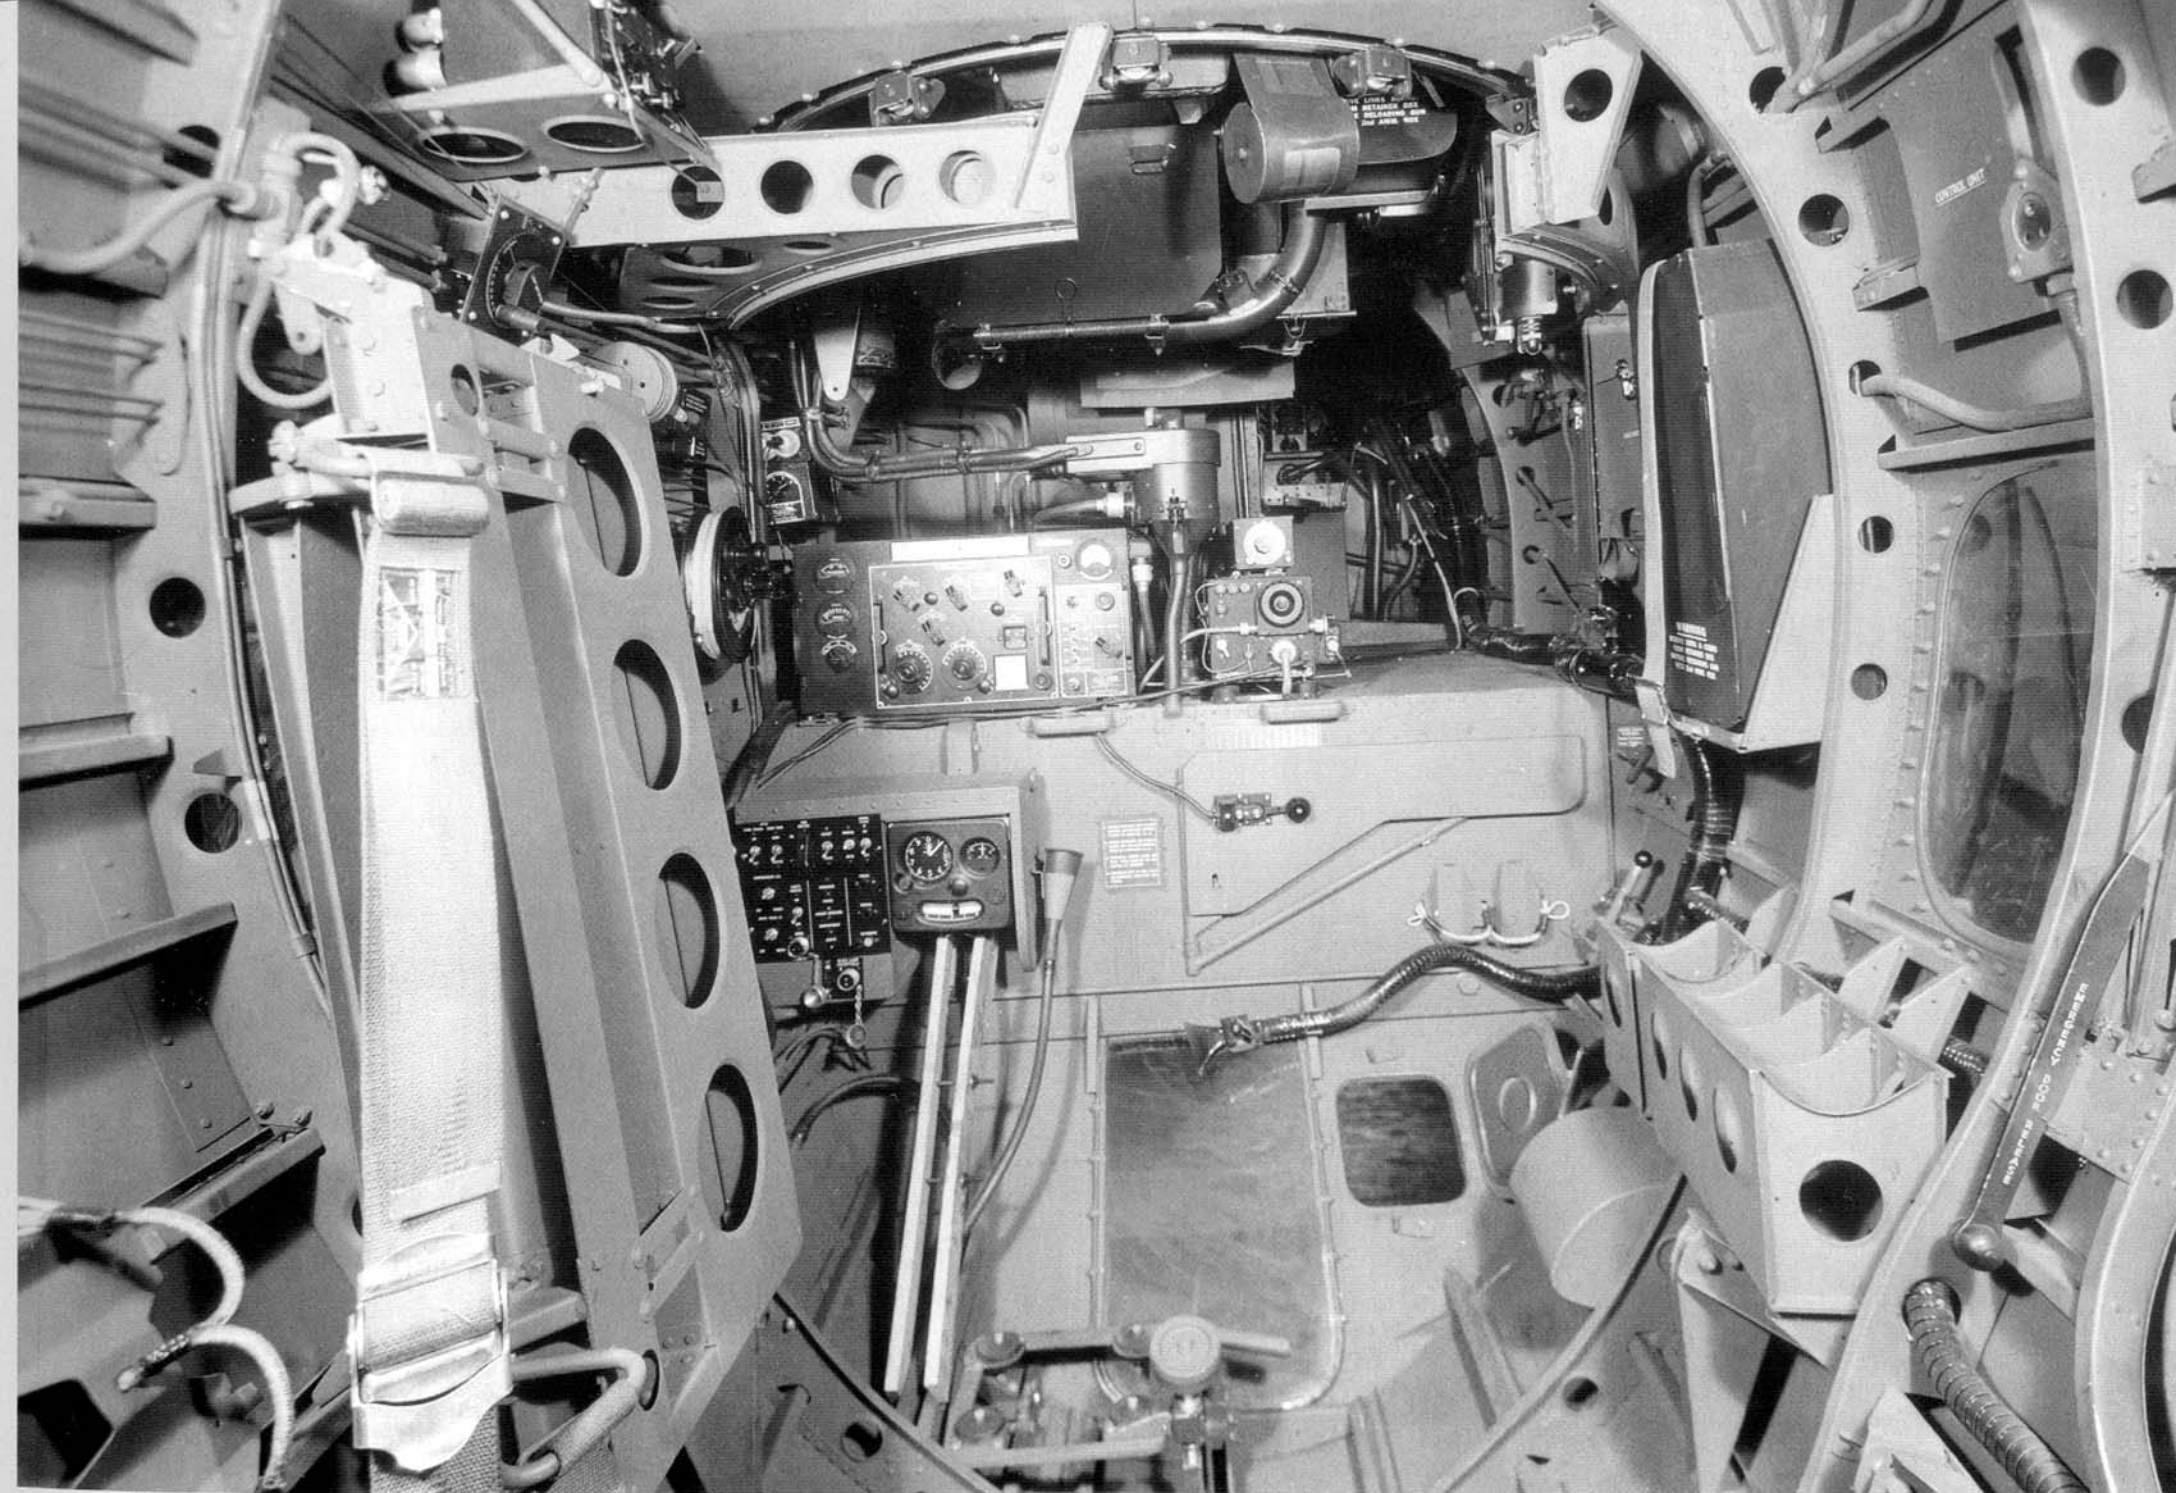
The TBF/TBM bombardier's station was located within the lower aft fuselage. The lower window – covered on the opposite side – looked into the bomb bay. The bombardier aimed through this window when the Avenger was on a level bombing mission. A radio trans-

mitter was placed above the bomb bay window. The bombardier's centerline seat was folded to port; this replaced a port mounted seat fitted to early TBF-1s. The turret and the radio operator's position were accessed from this compartment. (Lou Drendel)
